ERDC/EL TR-04-10

*Dredging Operations Technical Support Program
Monitoring Completed Navigation Projects Program*

Guidance and Lessons Learned from Monitoring Completed Navigation Projects

ERDC/EL TR-04-10
June 2004

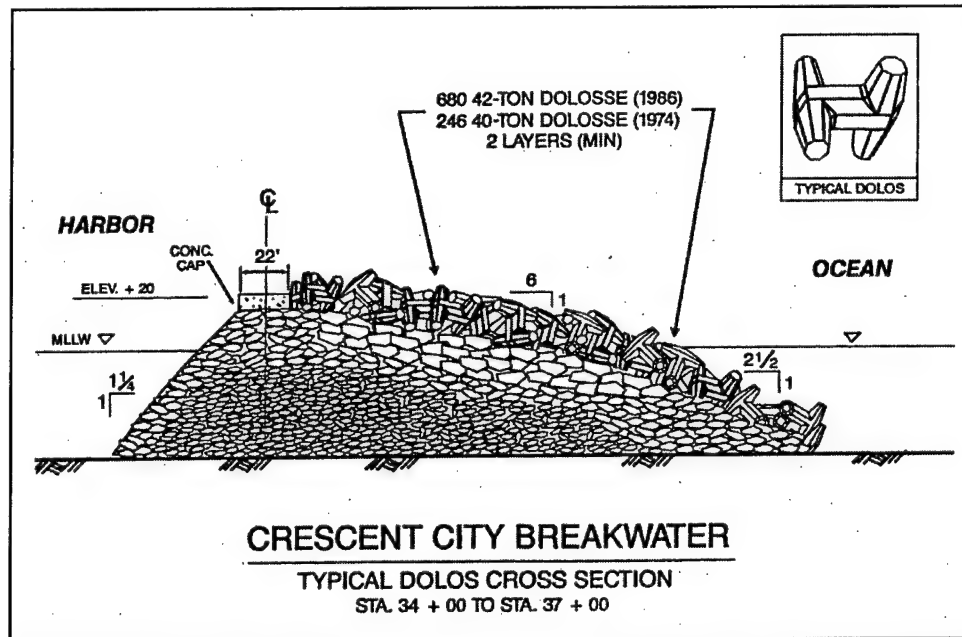
Figure 18. Crescent City breakwater cross section, Crescent City, CA (after Markle et al. 1995)

Crescent City Harbor is located at Crescent City, CA, on the northern California coastline, approximately 27 km (17 miles) south of the Oregon/California border. Rehabilitation of the breakwater in 1986 used 38,135-kg (42-ton) dolosse, 20 of which had been instrumented for response to the ocean environment, and which should be monitored and analyzed. A cross section of the rehabilitated breakwater is shown in Figure 18.

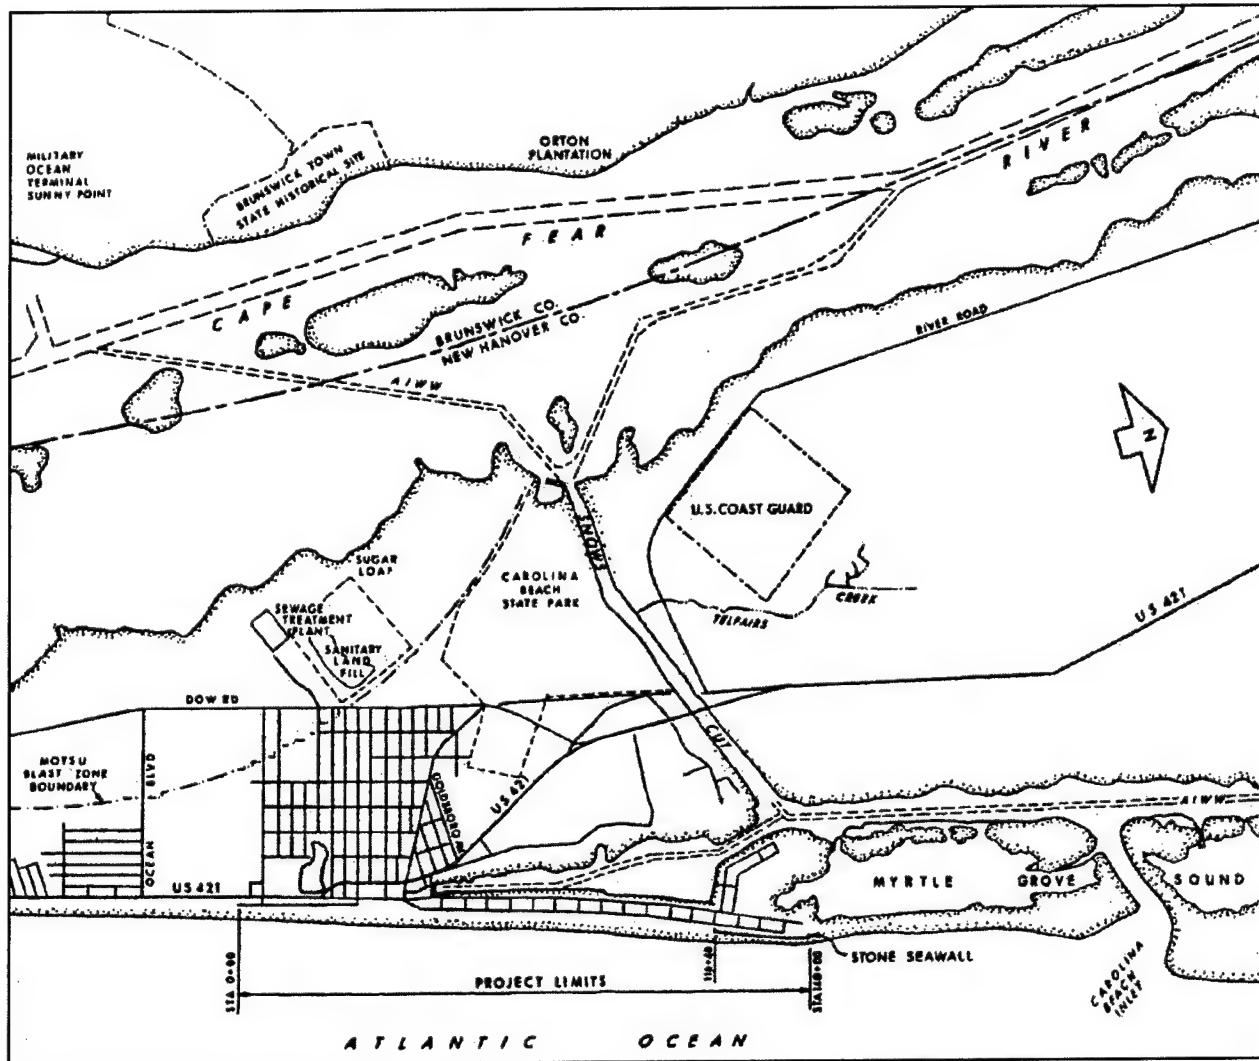
Figure 26. Carolina Beach, North Carolina (after Jarrett and Hemsley 1988)

- a.* The Carolina Beach project performed generally as expected, but experienced slightly higher volume losses than originally anticipated. Until the material in the construction berm along the southern 3,050 m (10,000 ft) of the project moves to the lower portion of the active profile, volume losses along this segment will probably continue to be high.

Eventually, the southern 3,050-m (10,000-ft) segment is expected to attain some degree of stability. Along the northern 1,220 m (4,000 ft), the sediment deficit caused by Carolina Beach Inlet remains a problem and will require a continuous renourishment program with materials obtained from the Carolina Beach Inlet sediment trap.

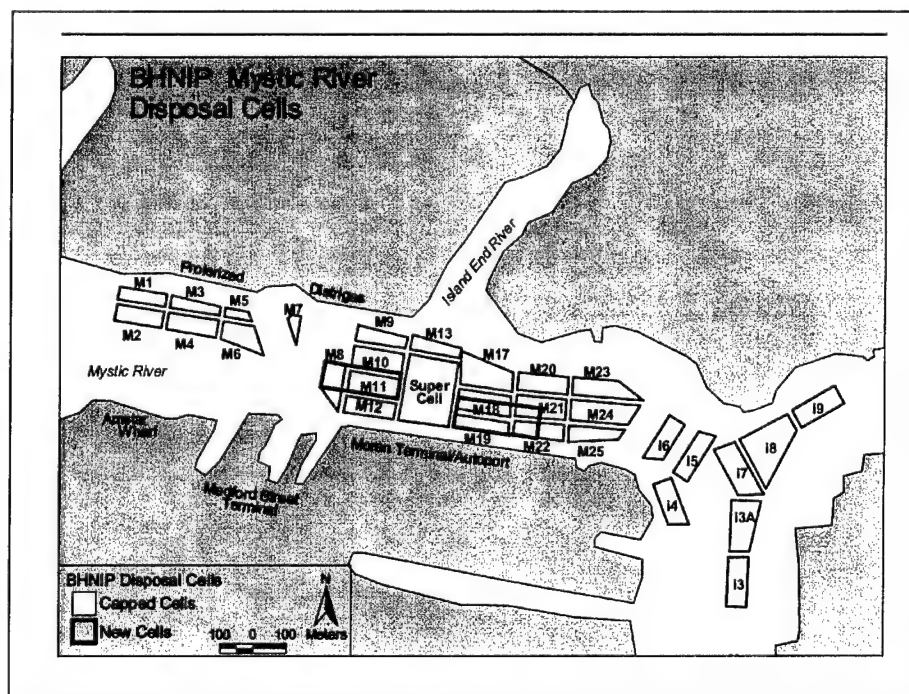
Figure 32. Confined Aquatic Disposal (CAD) cells being capped, Boston Harbor Navigation Improvement Project, Boston, MA (after Hales 2001)

- b. Grab samples and core samples indicated that: (1) natural cohesion and strength of the sediments were altered by the dredging process, resulting in sediments in the CAD cells that were unstable because of high water content and low shear strength; (2) excess pore water was released not only through the cap but also was vented through diapir structures that served to breach the caps in discrete areas; and (3) future projects should include an evaluation of the in situ strength of the material to be capped and the porosity and permeability of the CAD cell sediments.
